Fukushima Accident and Decommission Work

Fukushima Daiichi Nuclear Power Station
Then and Now

September 9, 2013

Sakae Muto

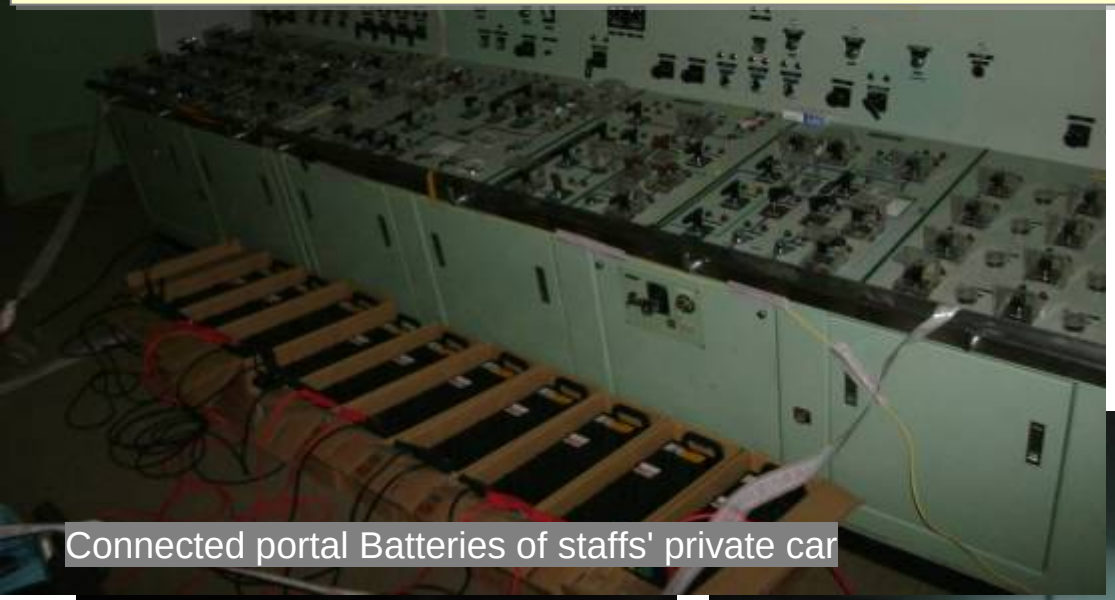
Connected portal Batteries of staffs' private car

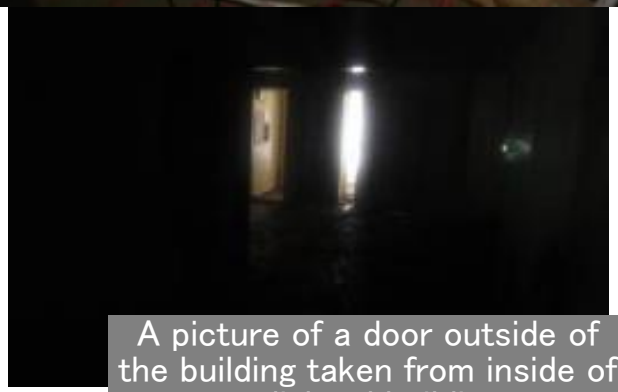
A picture of a door outside of the building taken from inside of unlighted building

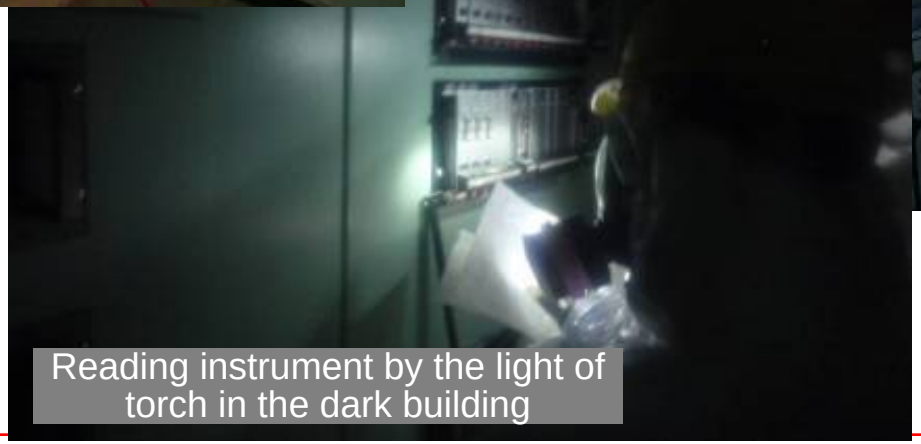
Reading instrument by the light of torch in the dark building

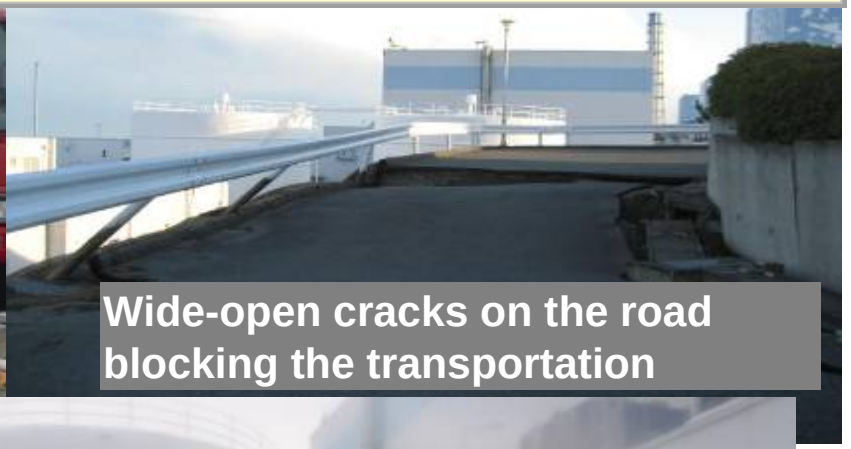
Wide-open cracks on the road blocking the transportation

Fire truck and scattered driftage

Heavy oil tank washed away by the tsunami and blocking the road

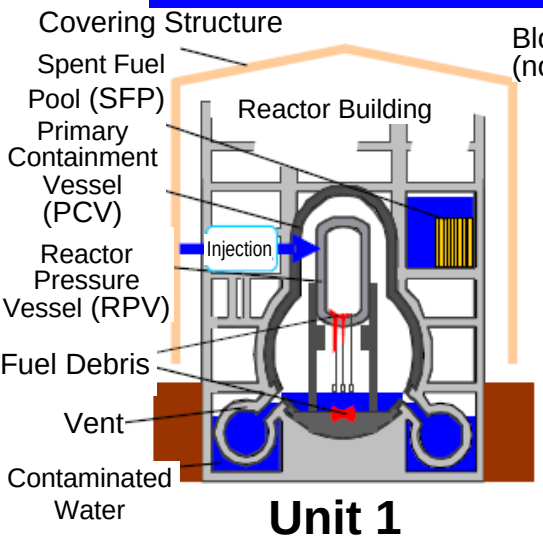
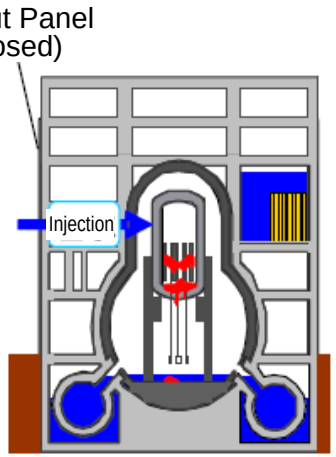
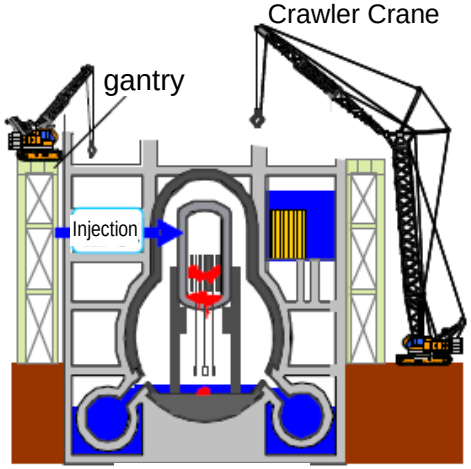
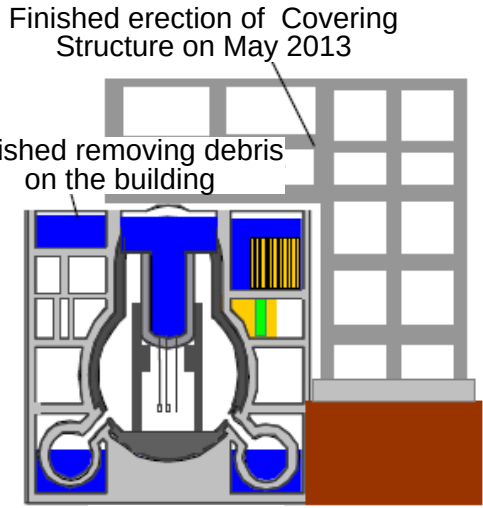
- At Units 1 through 3, circulatory water cools reactors. The temperature of the bottom of each of Units 1 and 3 reactor pressure vessels (directly measured from outside) has been kept between 30 and 50 degrees centigrade.
- We continue circulatory water-cooling system for Spent Fuel Pools of Units 1 through 4 to cool down spent nuclear fuels there.

RPV	33.2℃	43.7℃	43.0℃	No fuel
PCV	34.0℃	44.1℃	41.1℃	
SFP	29.0℃	27.5℃	26.2℃	38.0℃
